Subject: Pre-Blasting Survey of the Swapp and Sorenson Ranch; Alton Coal Development LLC,
Coal Hollow Mine, C/025/0005

PRE-BLASTING SURVEY
SORENSEN RANCH
FOR
ALTON COAL DEVELOPMENT, LLC
COAL HOLLOW MINE

BY
DAN W. GUY, P.E.
AUGUST 2, 2011

SORENSEN RANCH

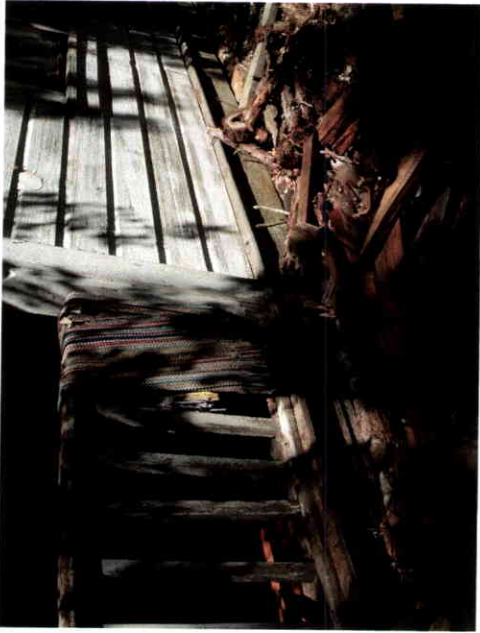
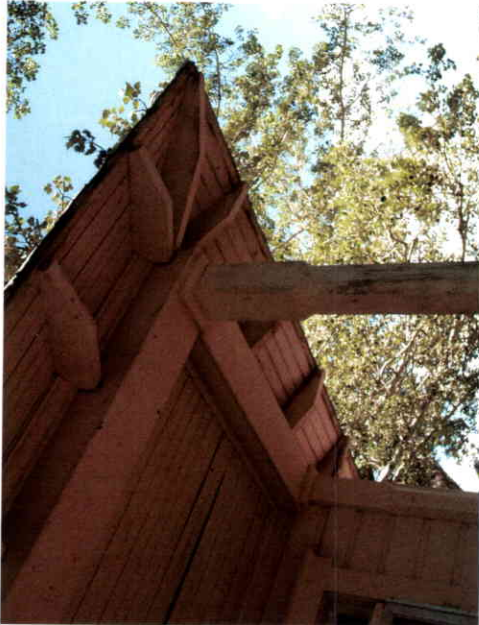
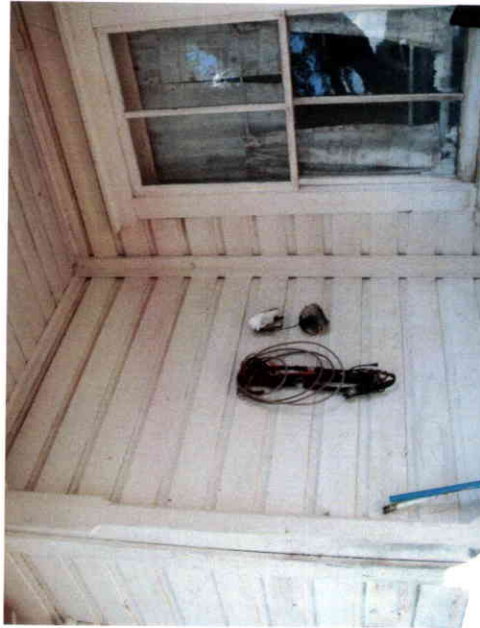
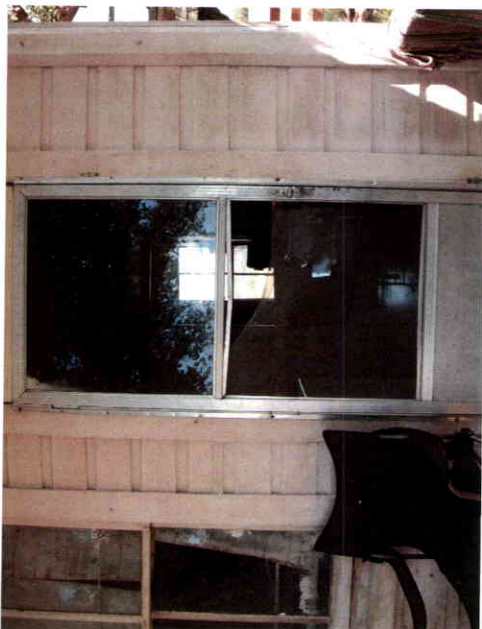
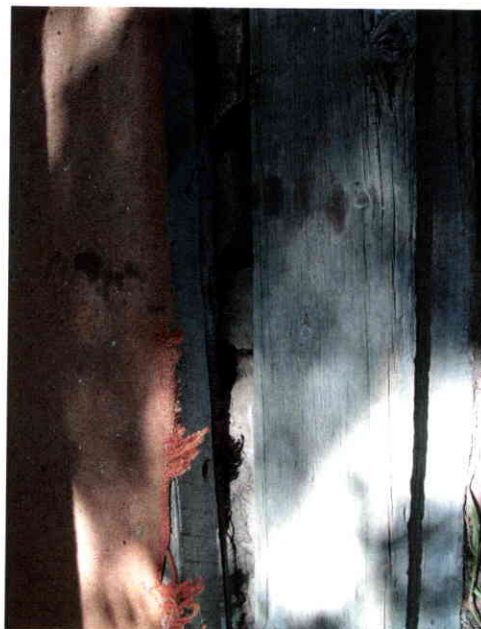
PLATE 3

Estimating the condition of a 100+ year-old house is very subjective. Compared to a newer, modern house, the condition may be considered poor; however, for a house of this age, I would consider it in fair to good condition. The house appears to have very little damage, except for wear on the floors and some sagging on the porch and steps. There were no broken windows observed during this survey. Because the interior walls and ceilings are mostly tin, the photos show some gaps at the overlap of the materials. There are some wall and ceiling areas where some "waving" is evident, but it doesn't appear to be actual damage or separation of the materials. Numerous photos were taken of both the interior and exterior of the ranch house. These are shown on Plates 3 through 13 of this report. The photos will provide the best assessment of the existing condition of the structure.

Plate 3 – Ranch House Exterior

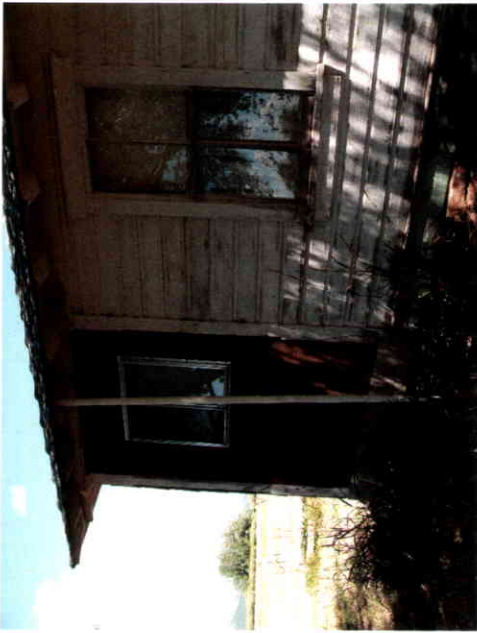
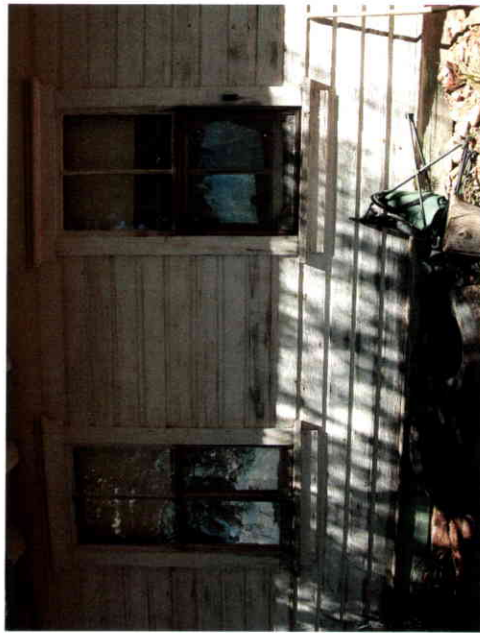
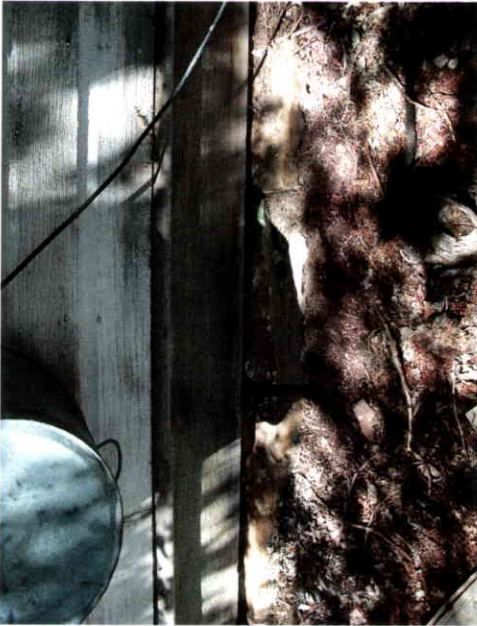
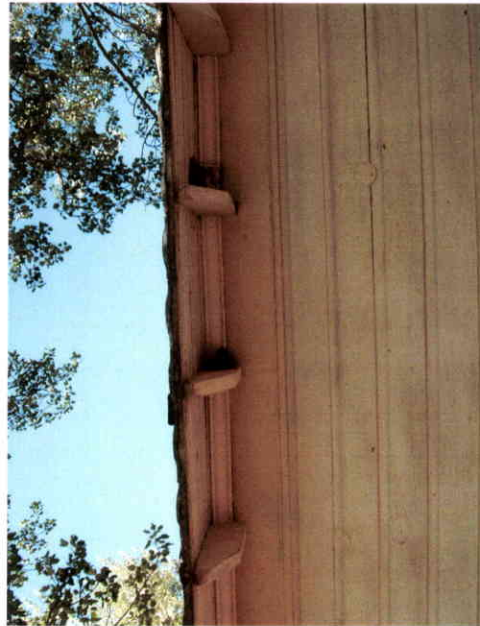
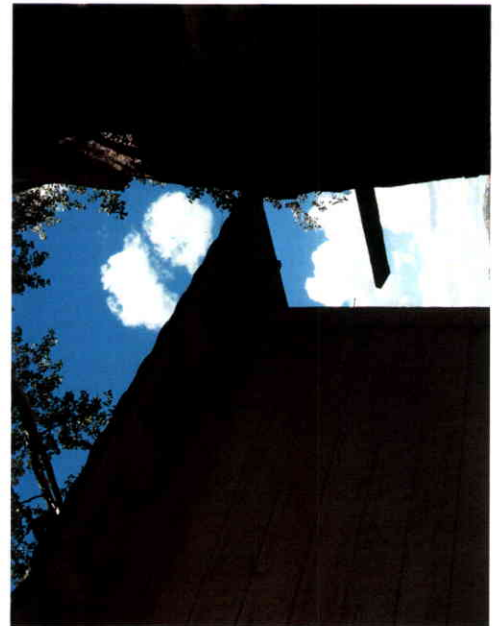
PLATE 4

Plate 4 – Ranch House Exterior

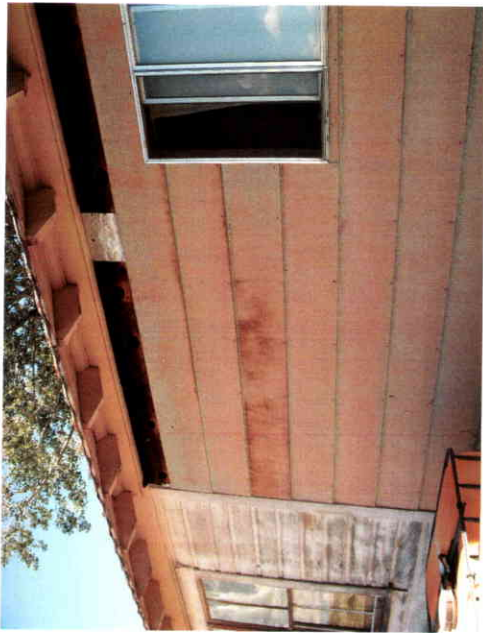
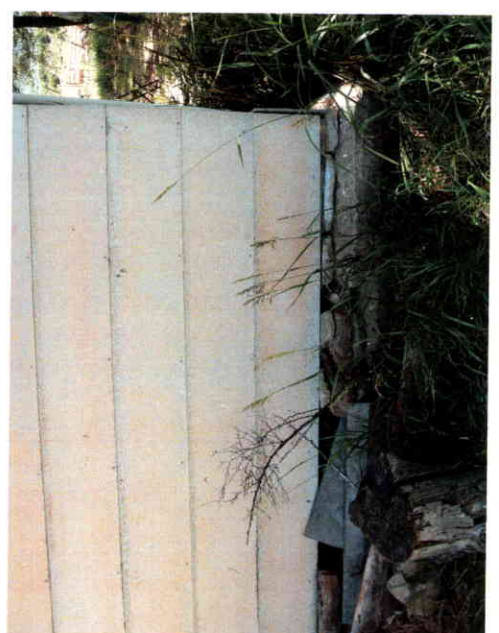
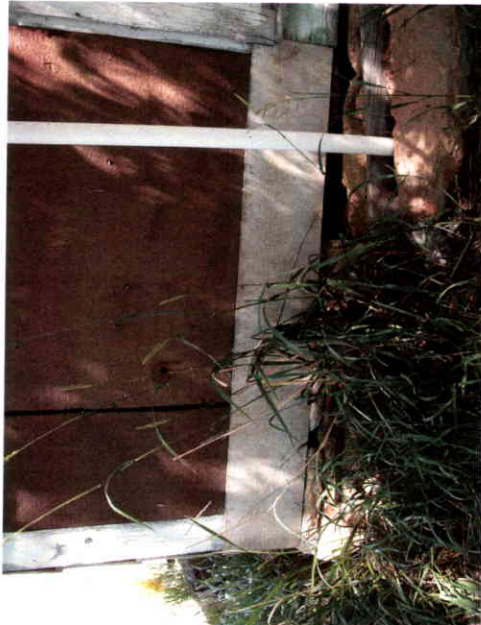
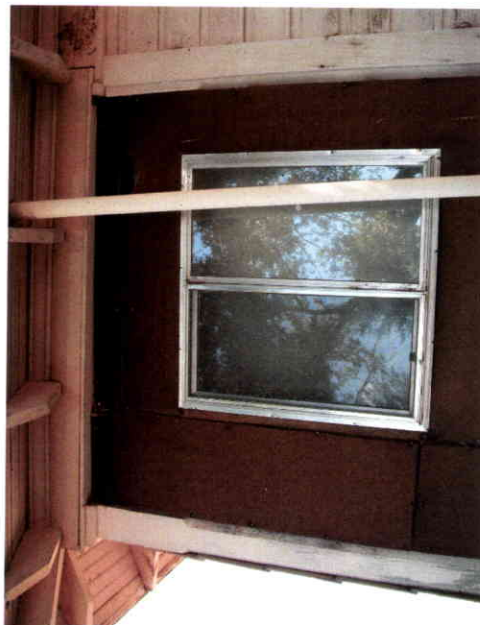
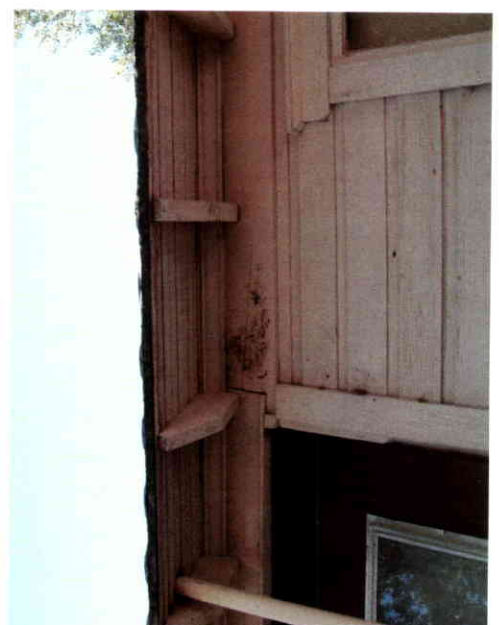
PLATE 5

Plate 5 – Ranch House Exterior

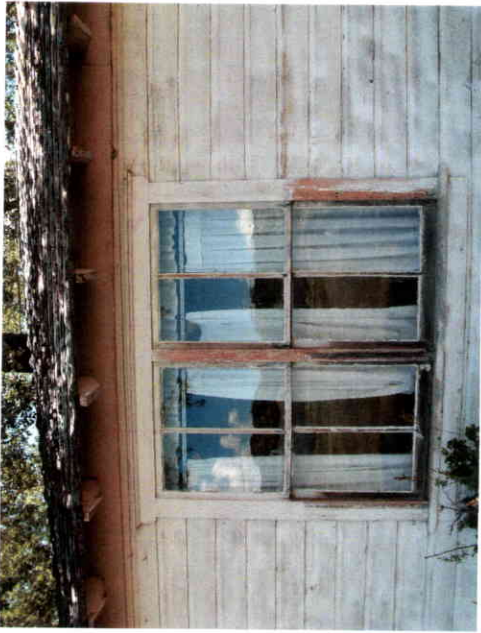
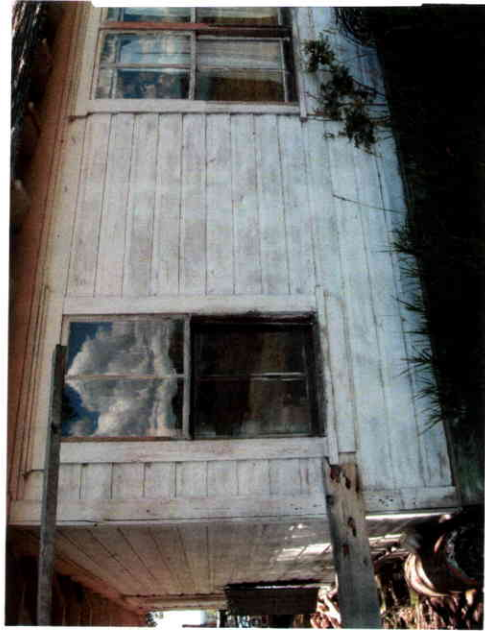
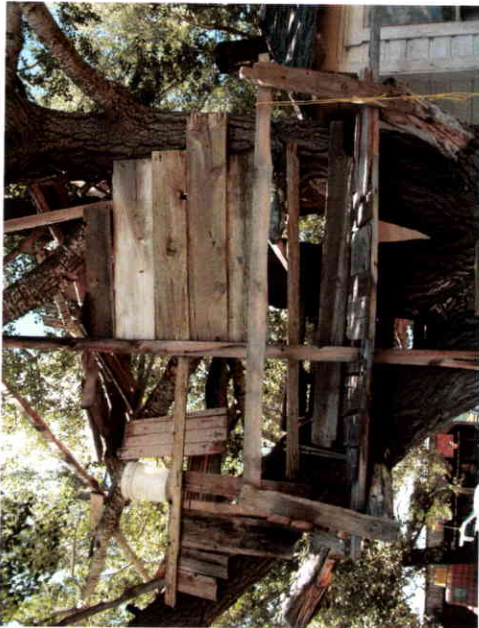
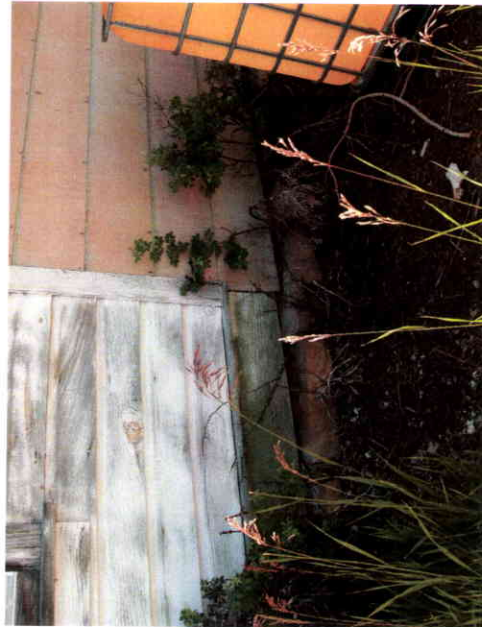
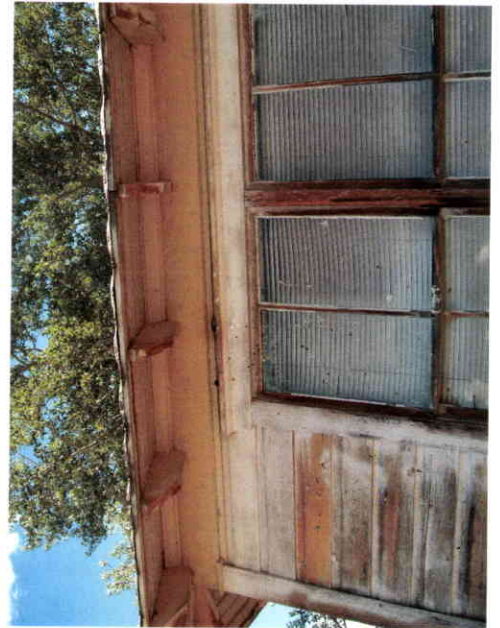
PLATE 6

Plate 6 – Ranch House Exterior

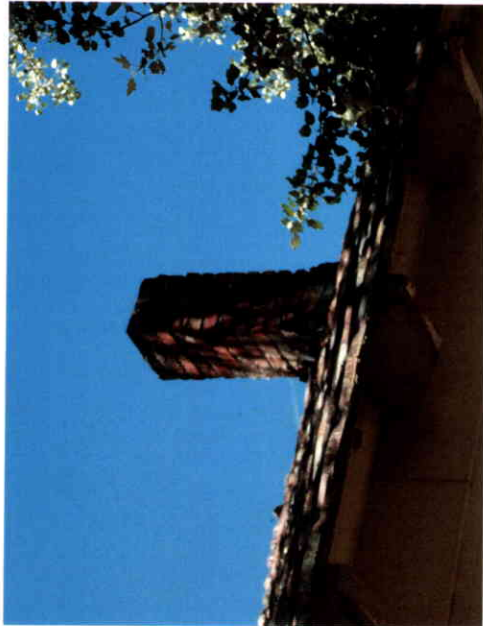
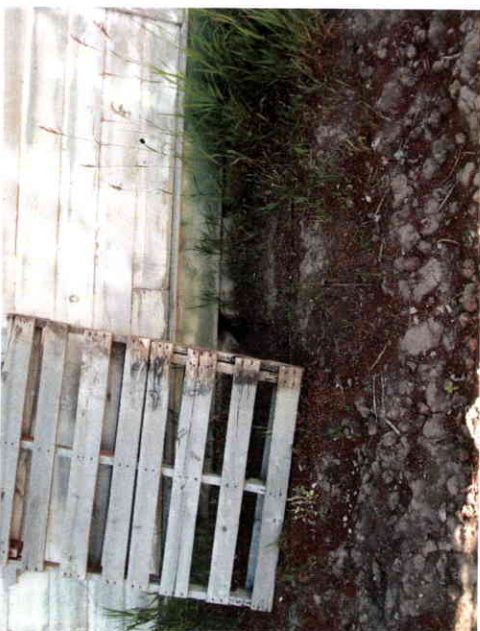
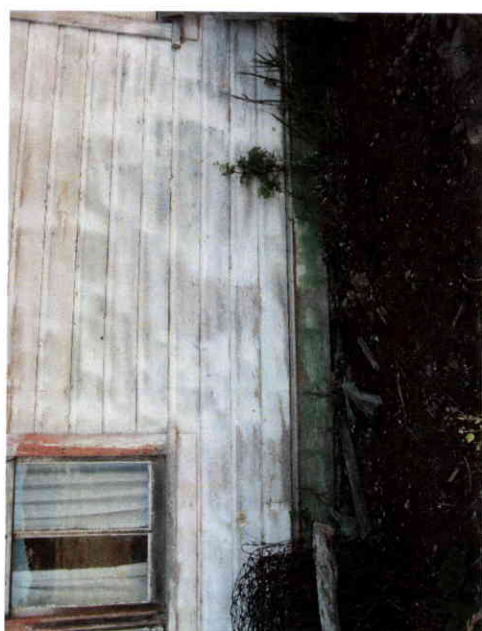
PLATE 7

Plate 7 – Ranch House Exterior

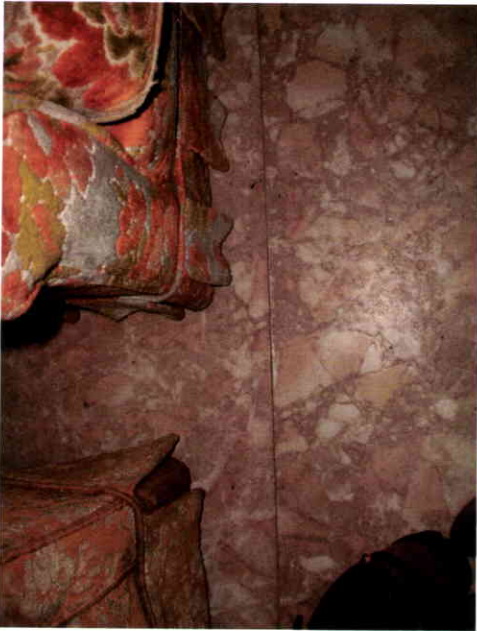
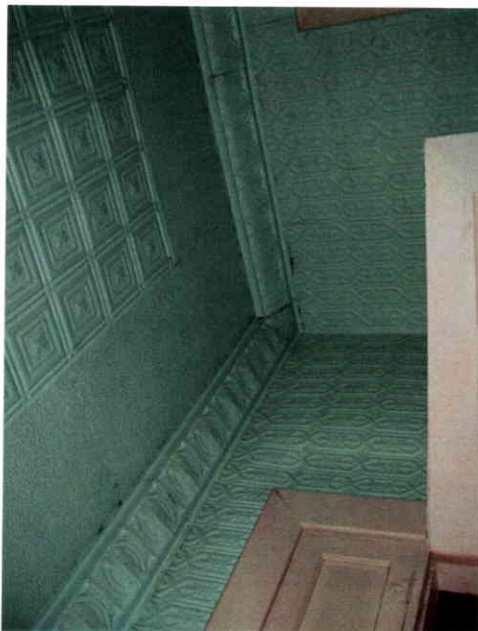
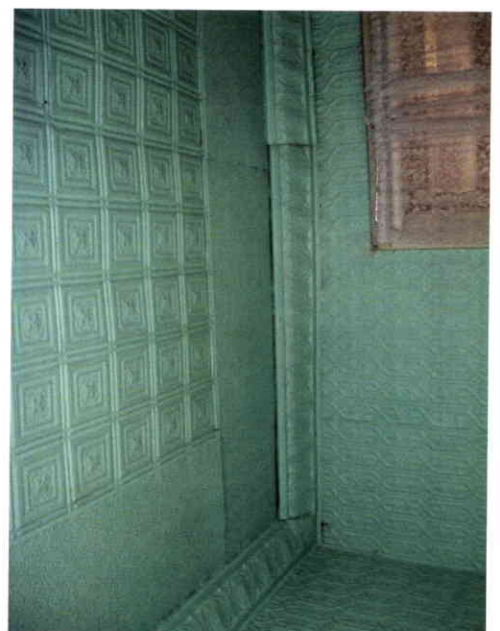
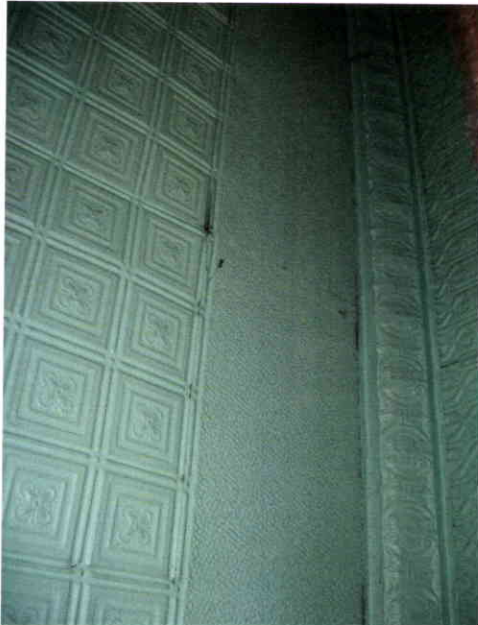
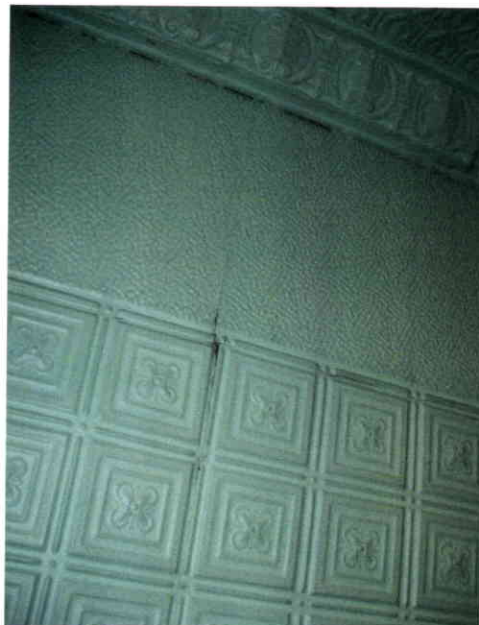
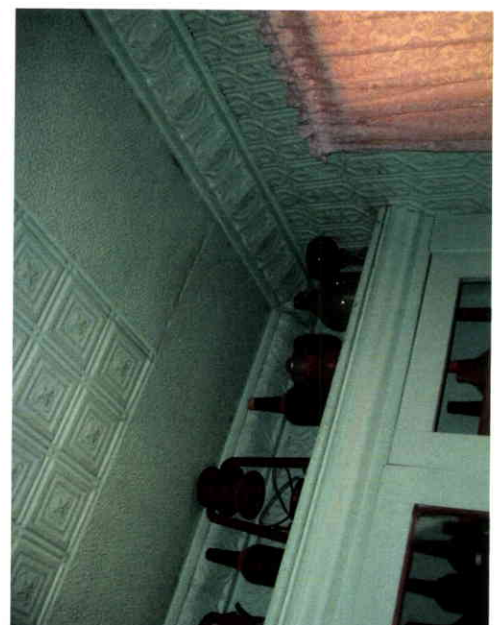
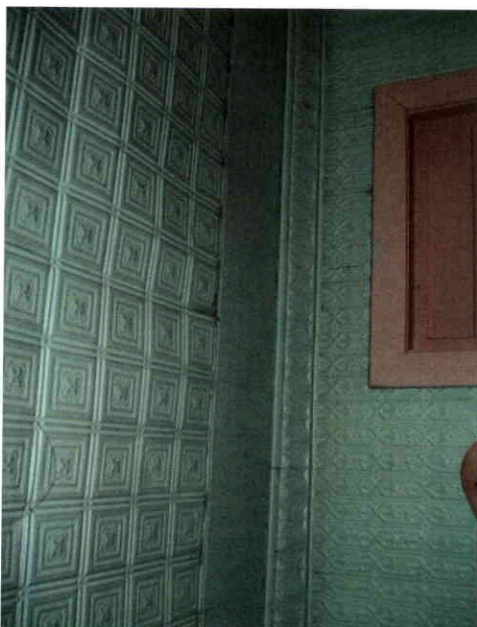
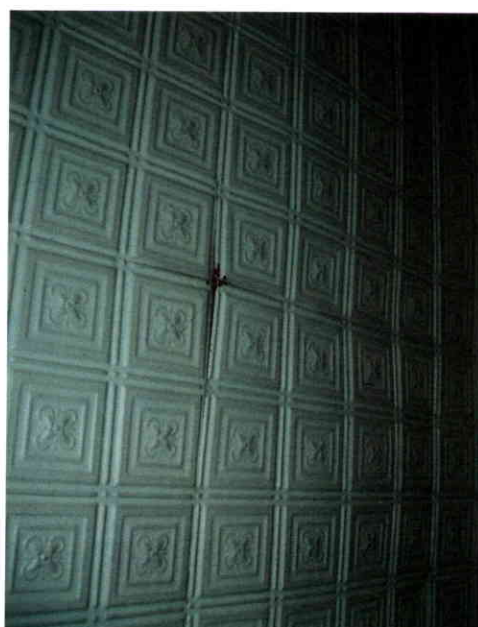
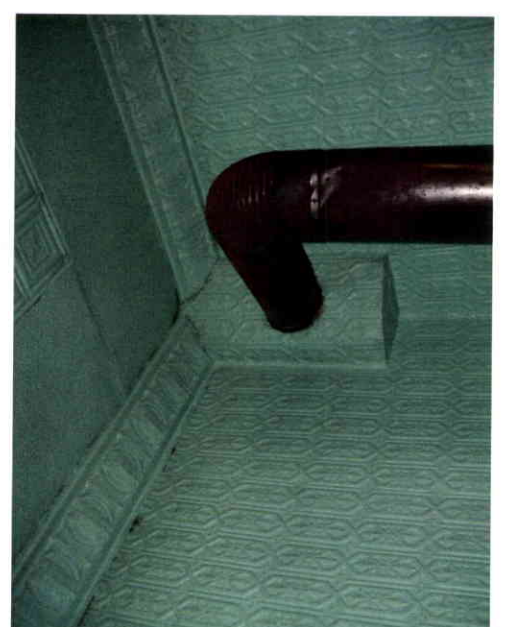
PLATE 8

Plate 8 – Ranch House Interior

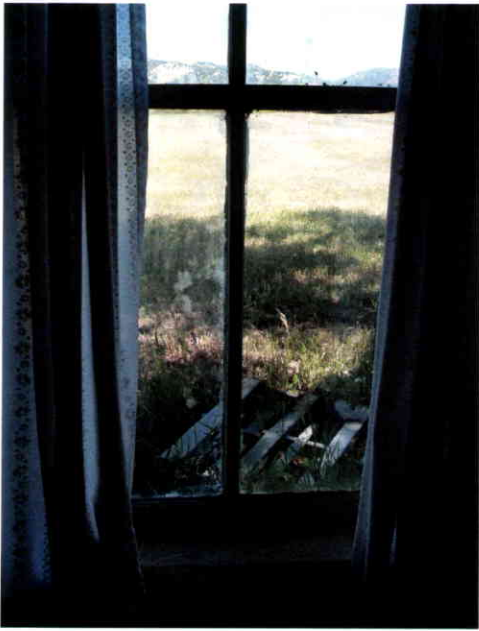
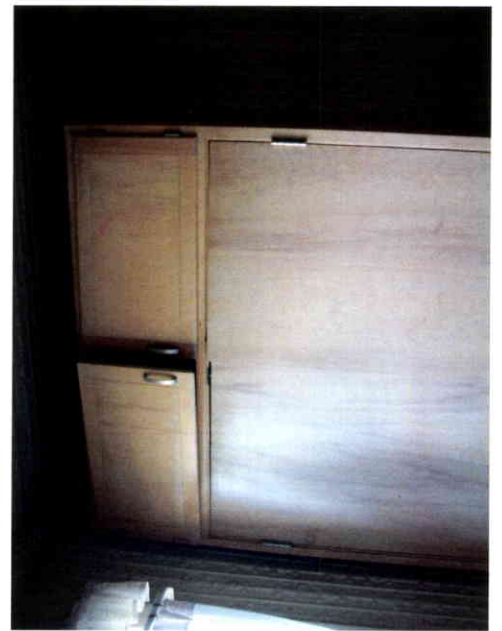
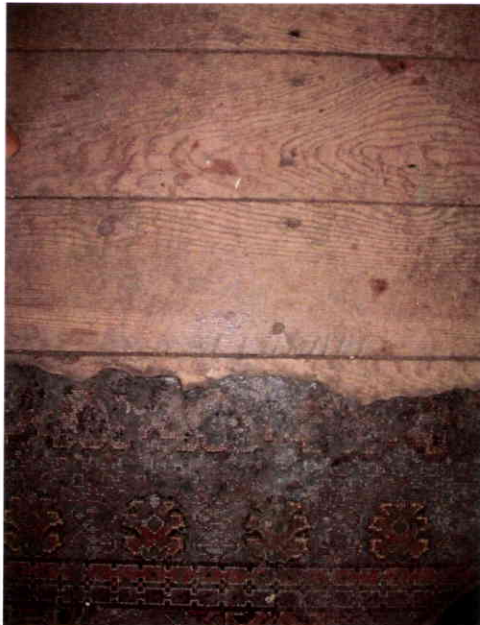
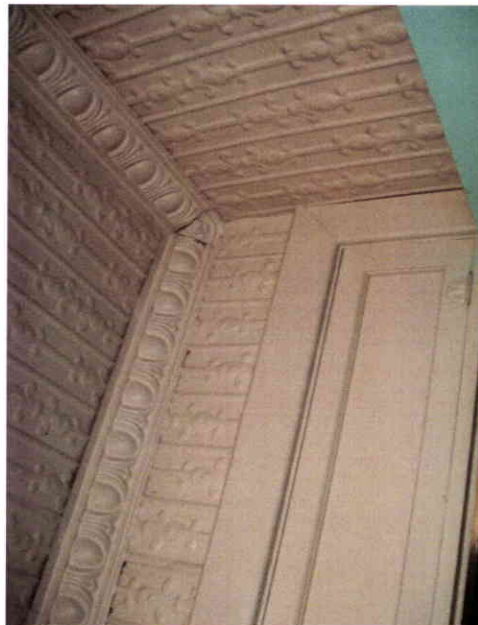
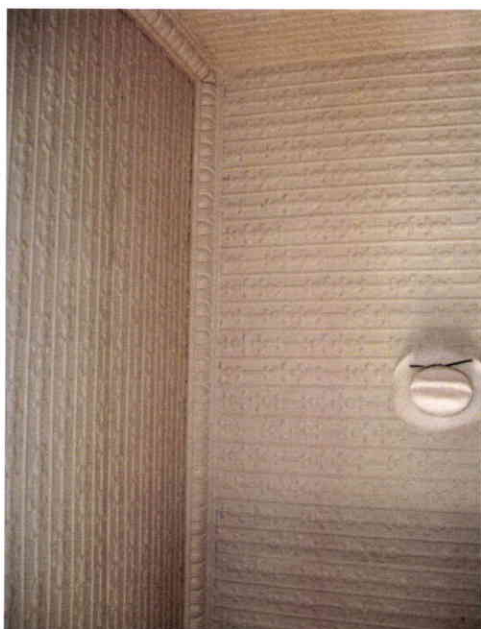
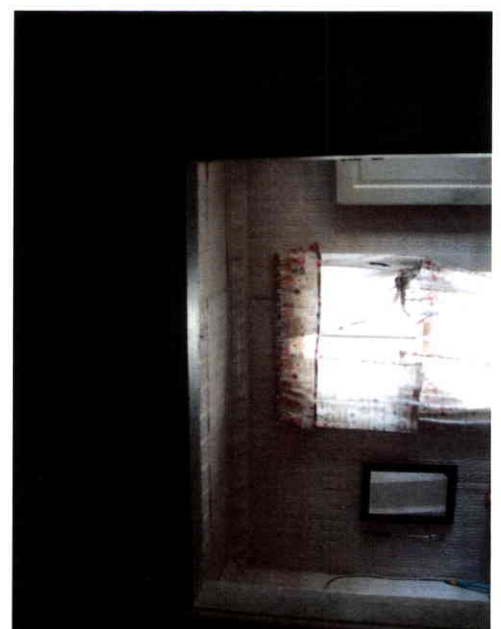
PLATE 9

Plate 9 – Ranch House Interior

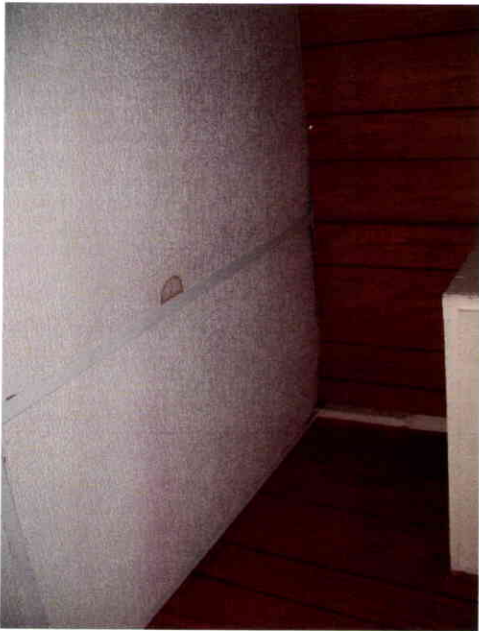
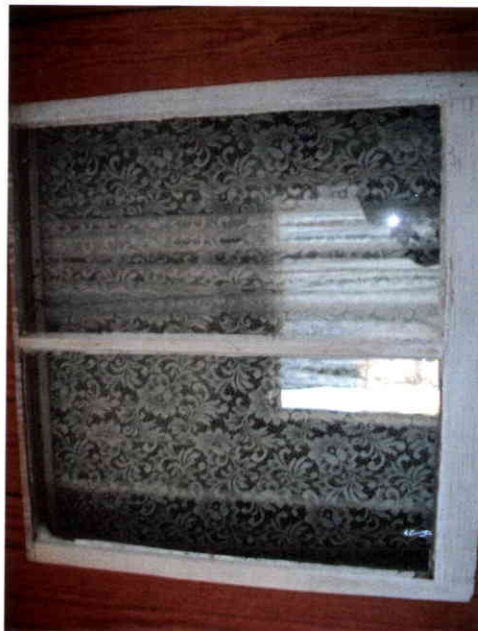
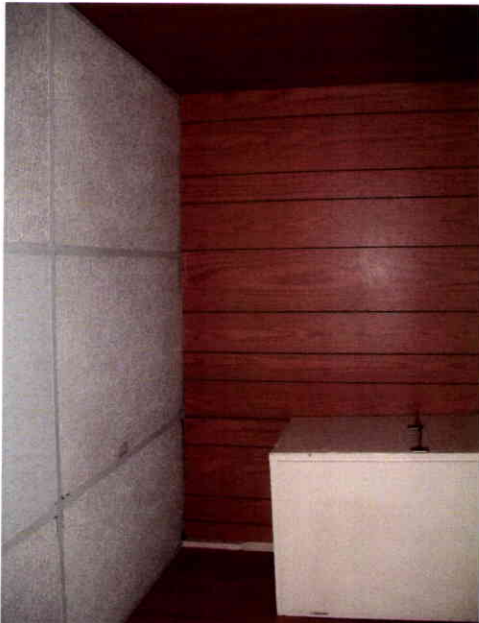
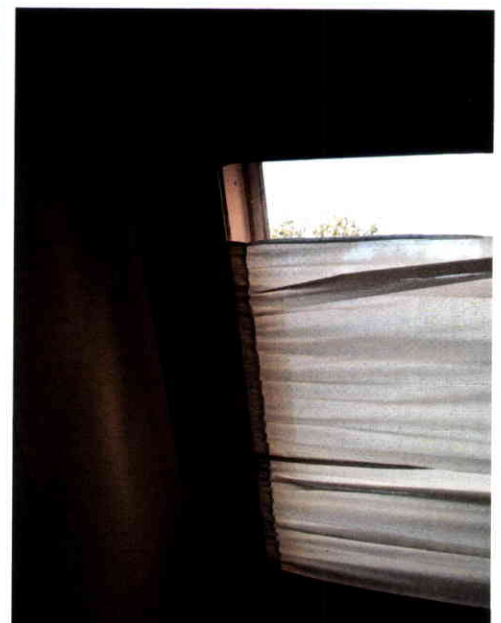
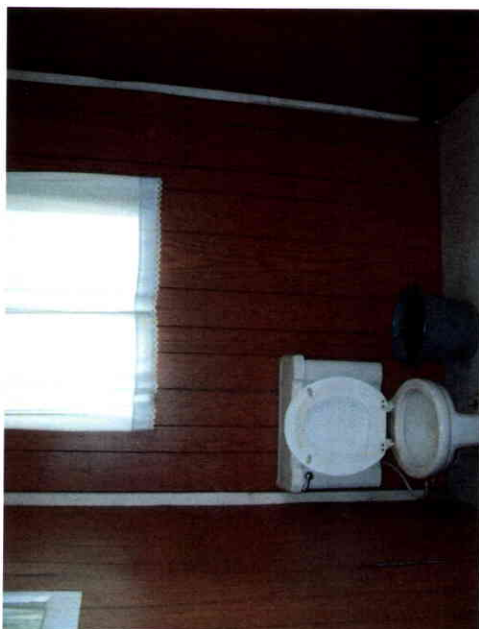
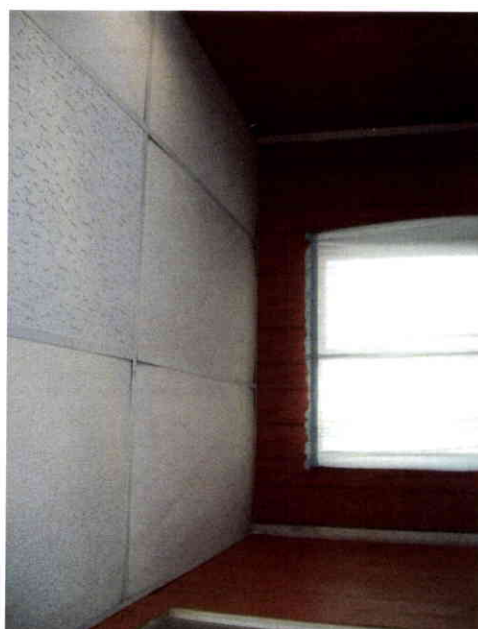
PLATE 10

Plate 10-Ranch House Interior

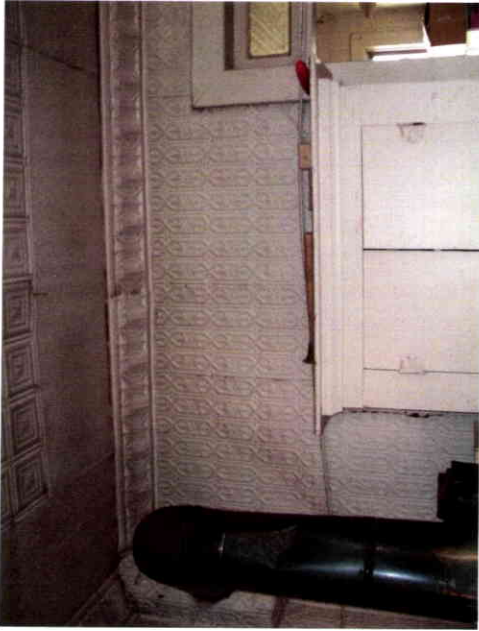
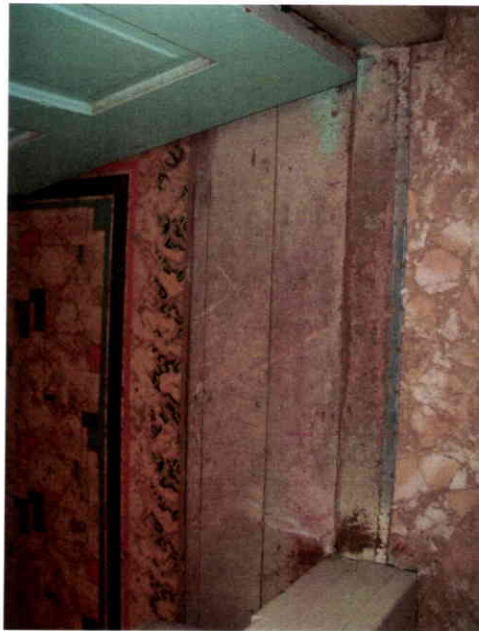
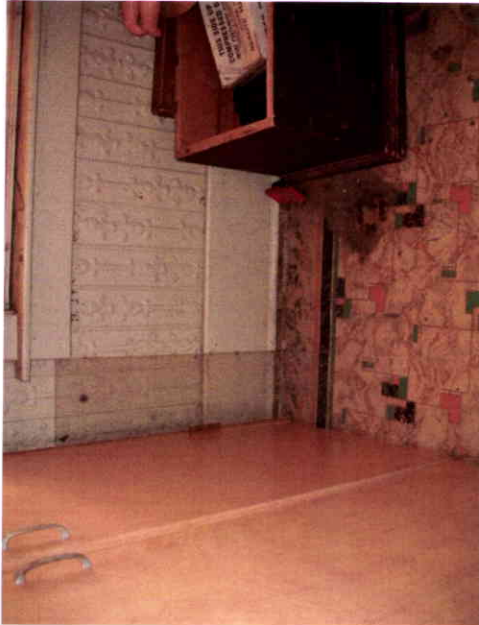
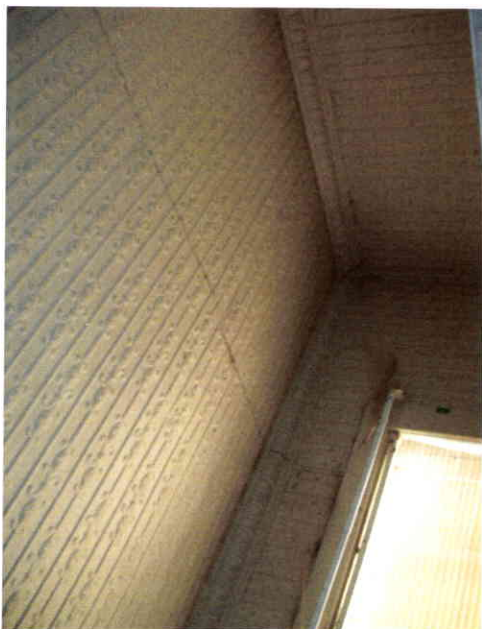
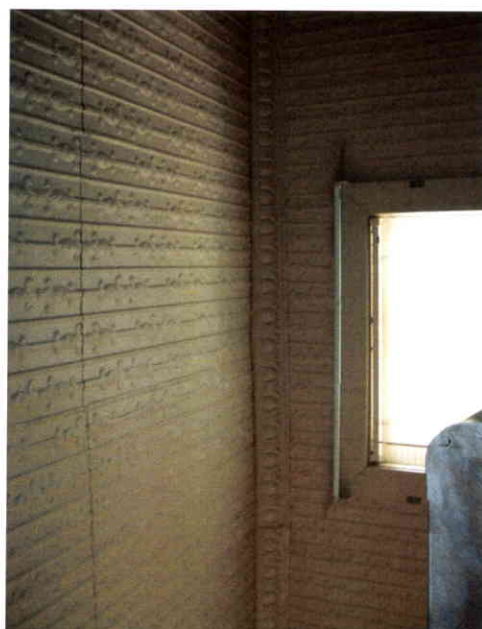
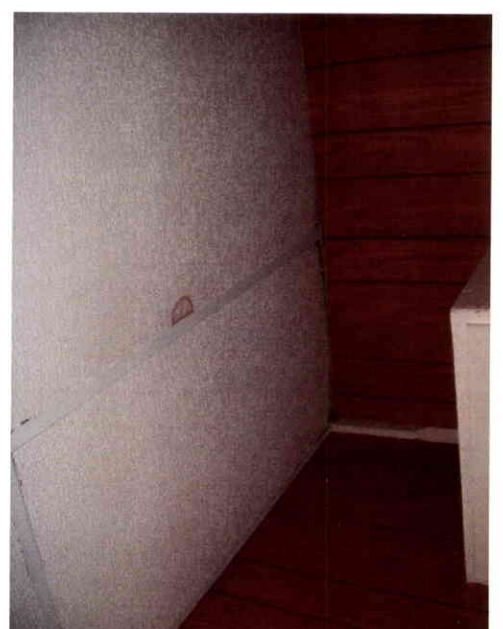
PLATE 11

Plate 11-Ranch House Interior

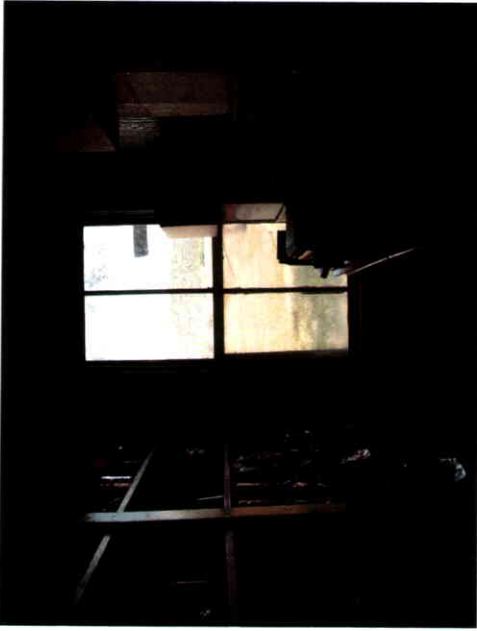
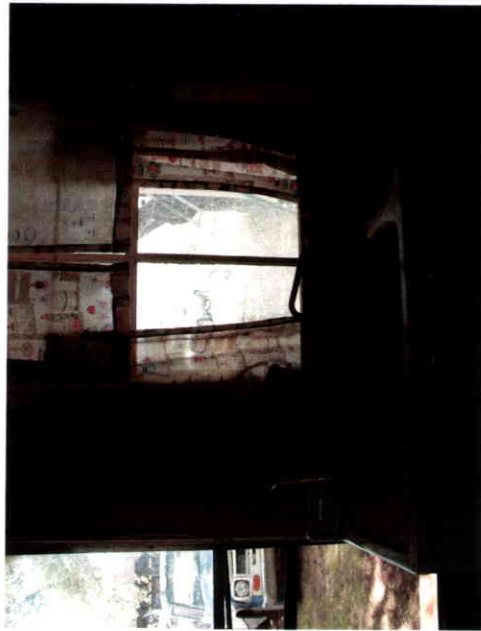
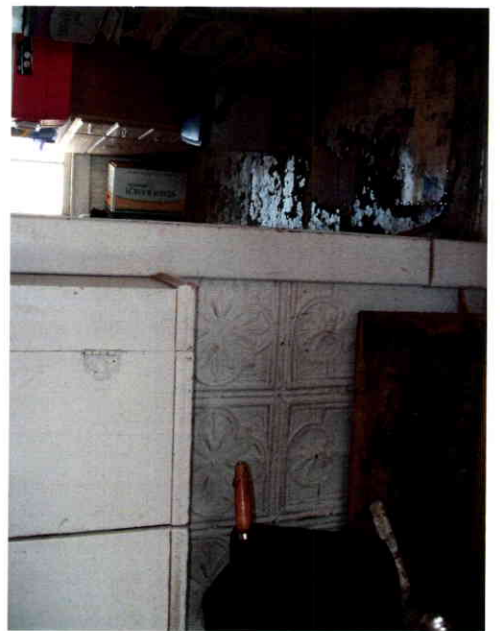
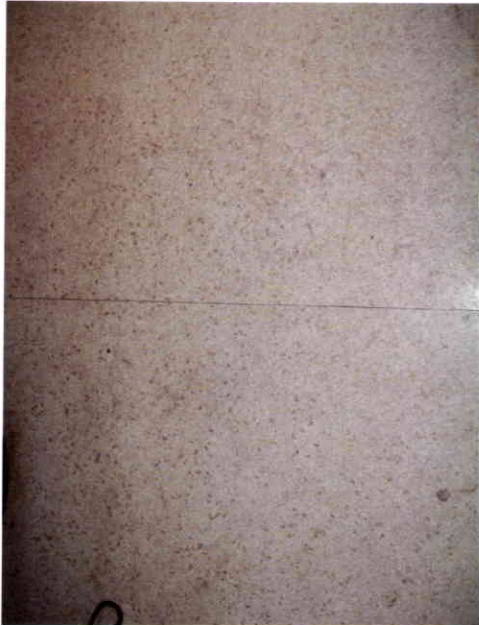
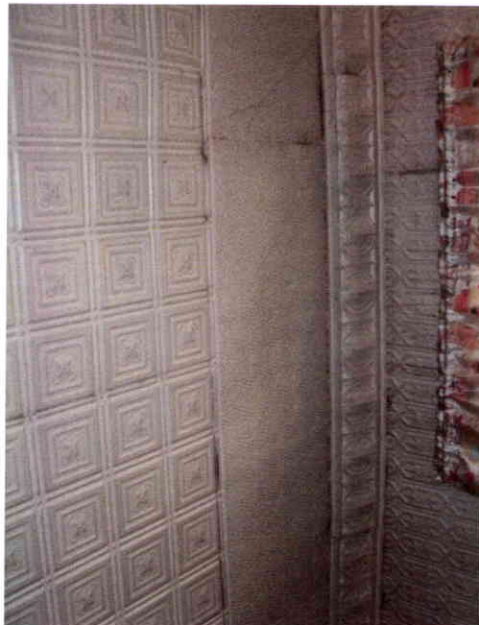
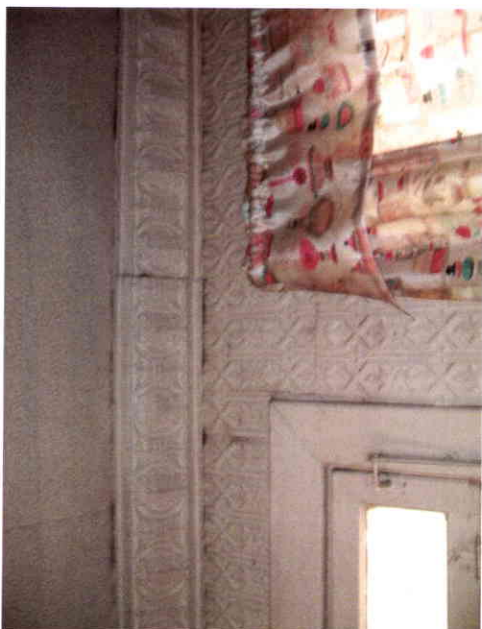
PLATE 12

Plate 12-Ranch House Interior

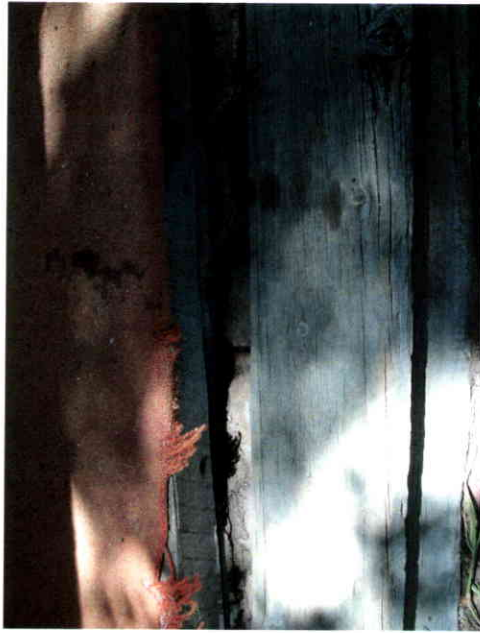
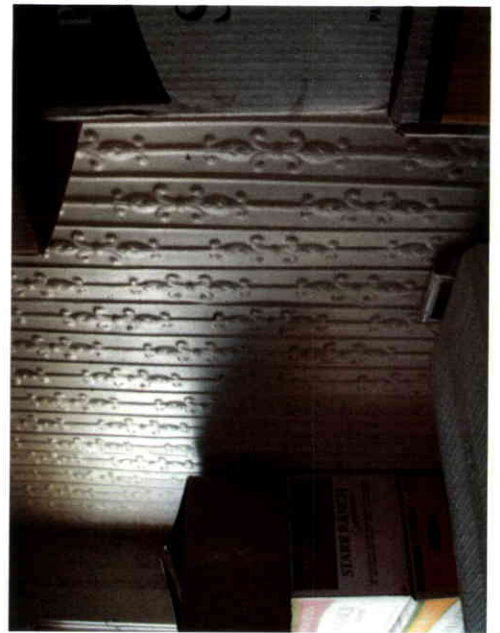
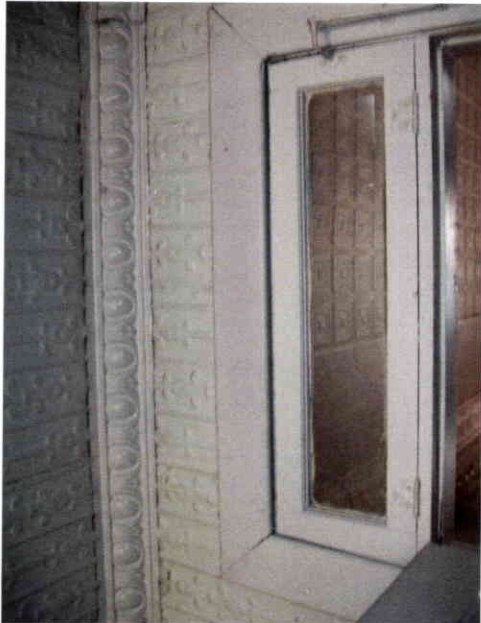
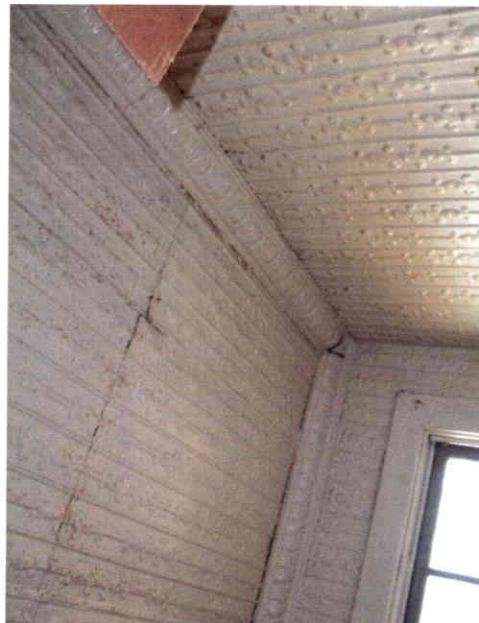
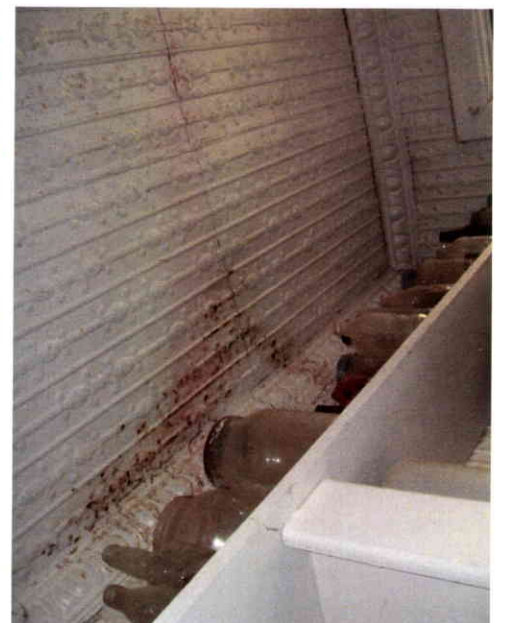
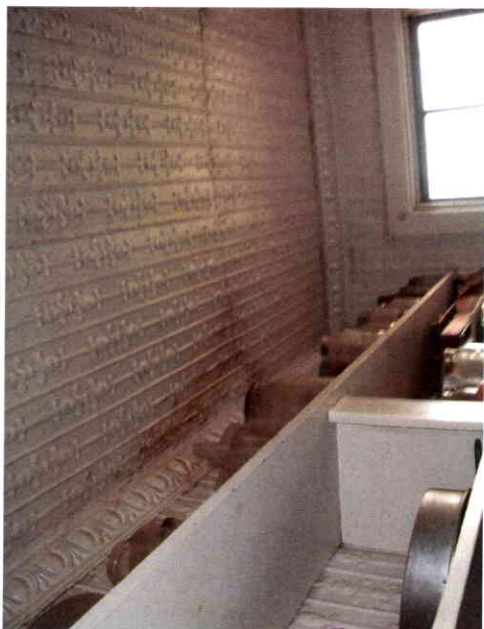
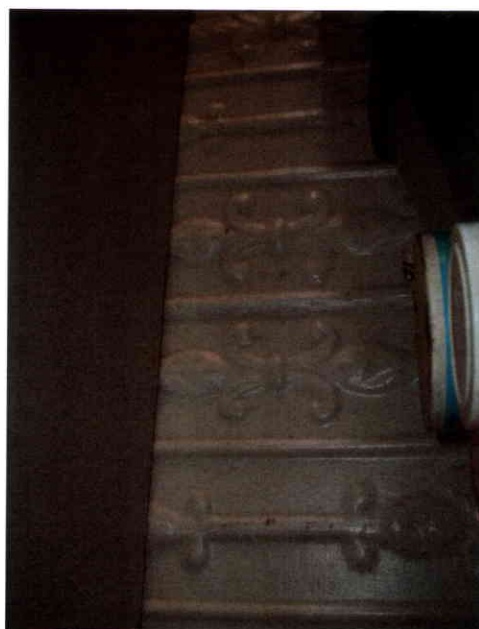
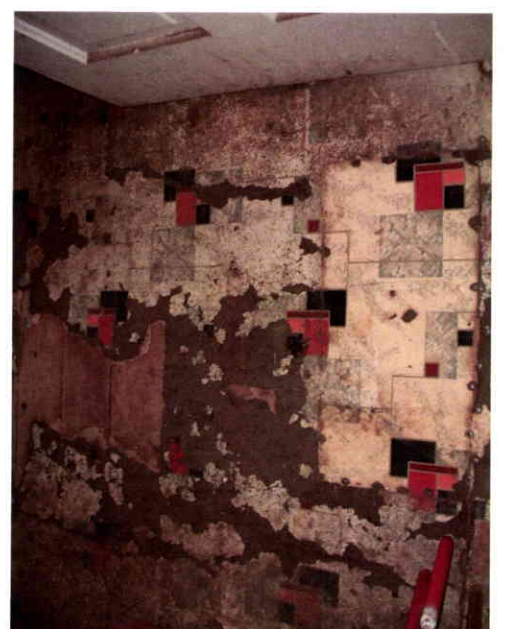
PLATE 13

Plate 13-Ranch House Interior

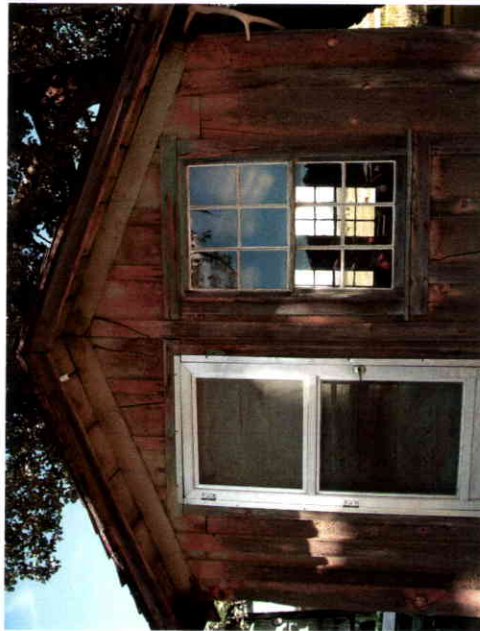
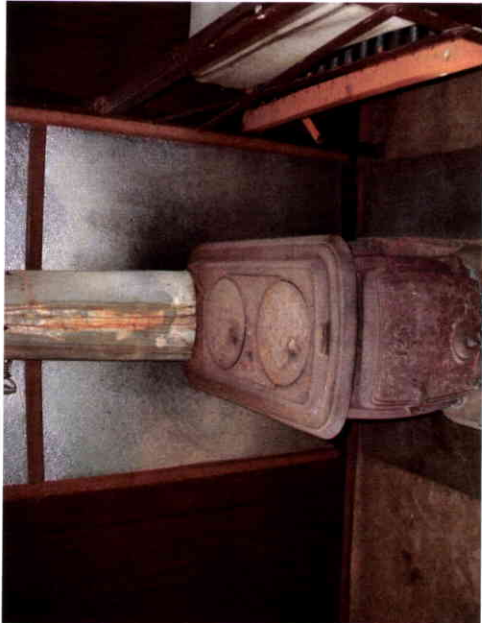
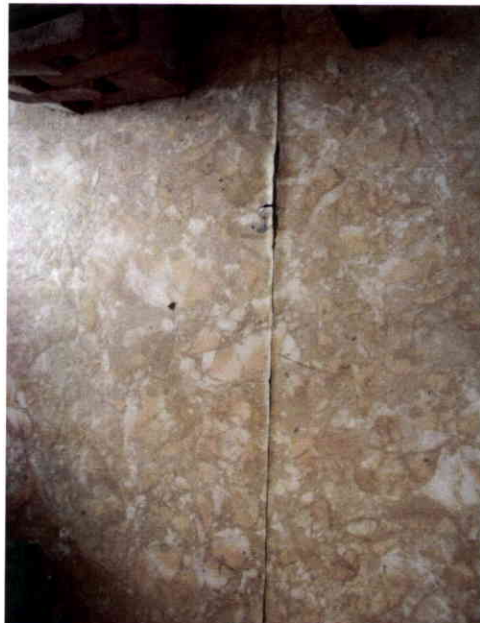
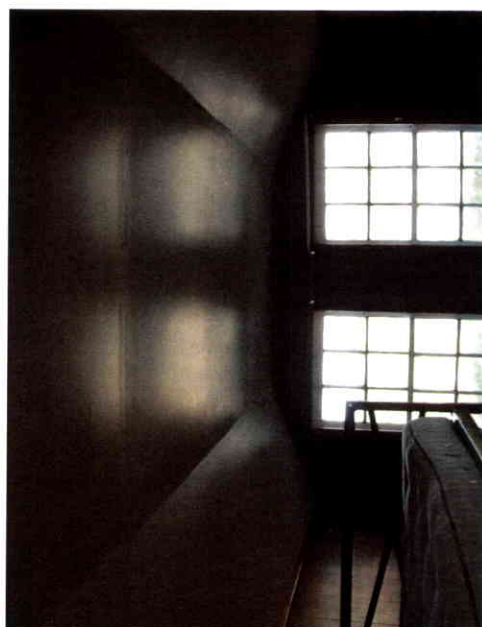
PLATE 14

Guest House – The guest house is wood construction inside and out, and sits on a plank on rock foundation as shown on Plate 14. The interior has paneled walls, linoleum floor and sheetrock ceiling. The owner said it was a motel cabin that has been moved onto the site. The house has no plumbing or power. It does have a wood/coal stove, three multi-pane windows and a newer aluminum storm door.

The interior of the guest house is in relatively good condition. The only existing damage noted inside is some cracking in the linoleum flooring at a seam and near the doorway. The exterior of the structure is mostly unfinished, rough wood. One area of concern is some of the vertical plank foundation supports are shifting, leaving some potential for future settling. The interior and exterior views of the guest house, along with photos of the areas described above, are shown on Plates 14 and 15.

Plate 14-Guest House Interior

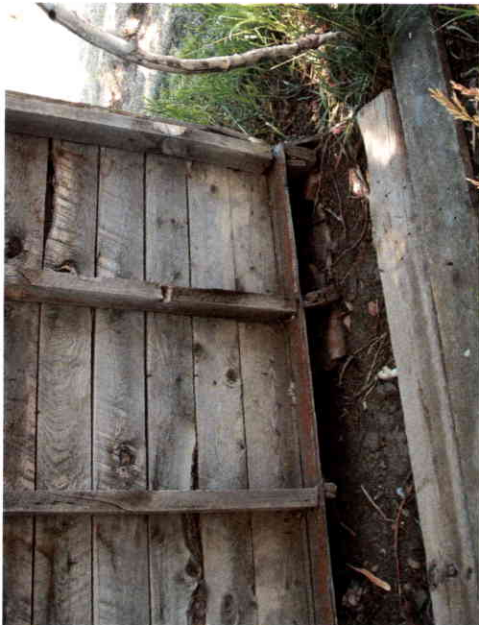
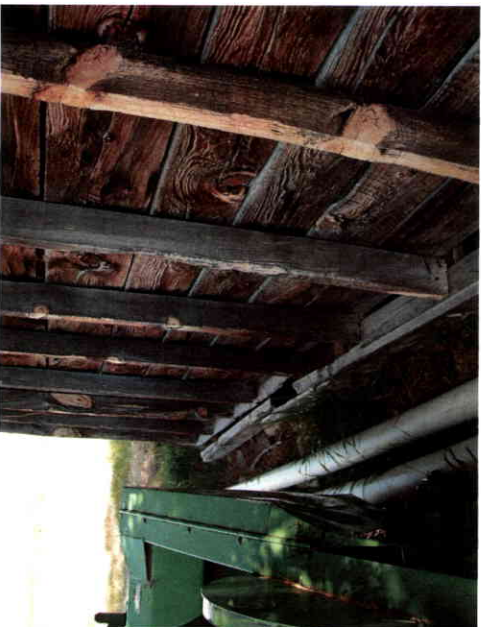
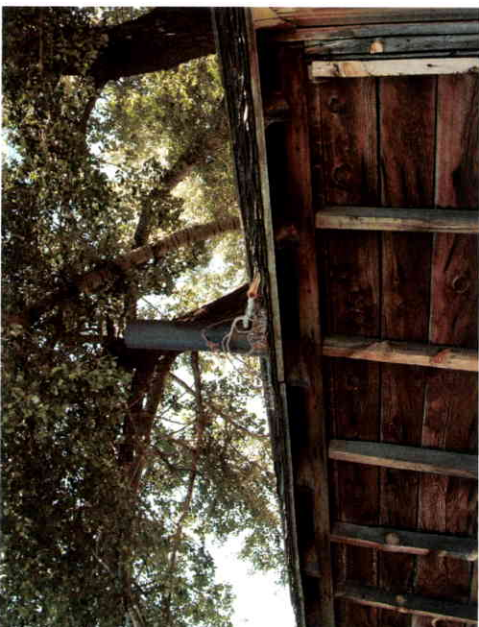
PLATE 15

Plate 15-Guest House Exterior
